No. 01-23

Gates fuel lines

### **GUIDELINES FOR INSPECTION AND REPLACEMENT OF FUEL LINES**

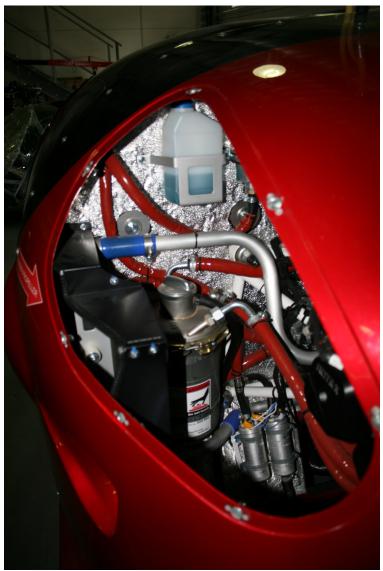
Figure 1\_View after cover remove

1. Remove the cover covering the left side of the engine.

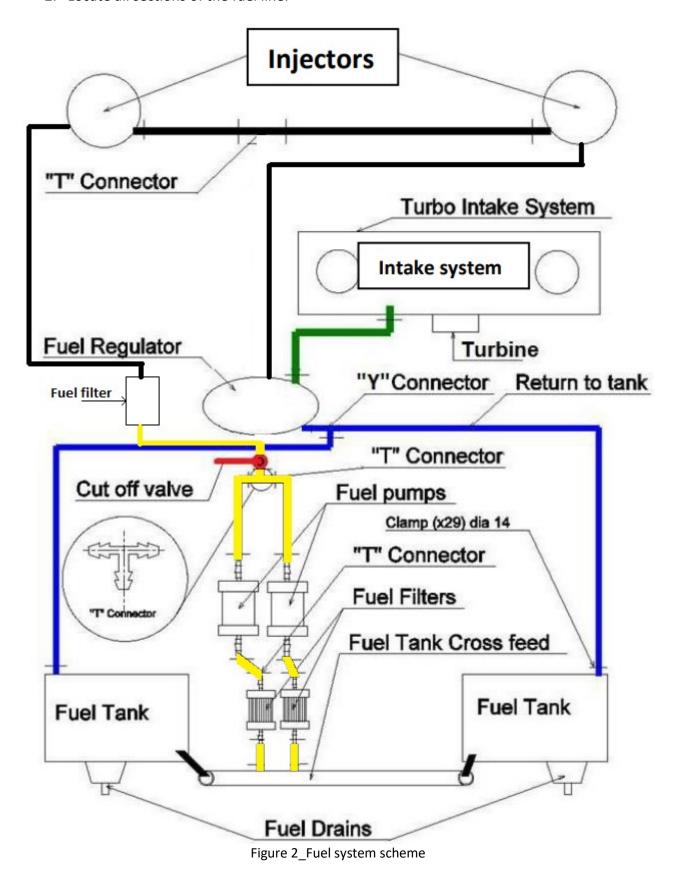
2. Locate all sections of the fuel line.

In the diagram above, the fuel lines necessary to locate are marked in yellow and blue.

In fact, these fuel lines are black, and some of them are additionally covered with a red cover tube.

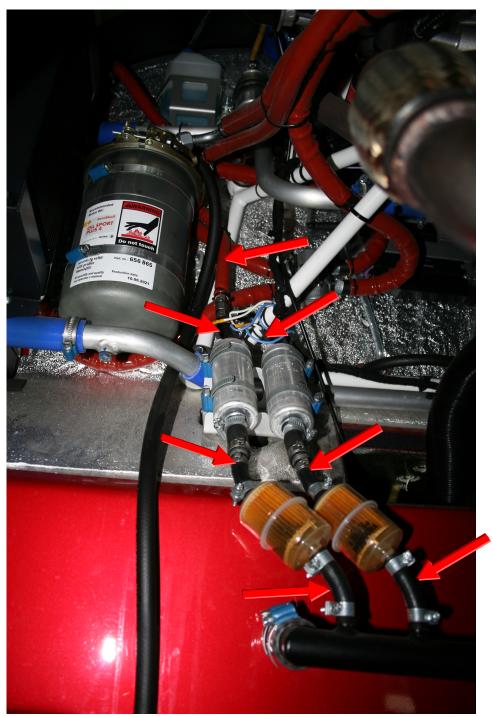
Figure 3\_Fuel system components

The sections of fuel lines to be looked for are indicated by red arrows in Figure 3-7.

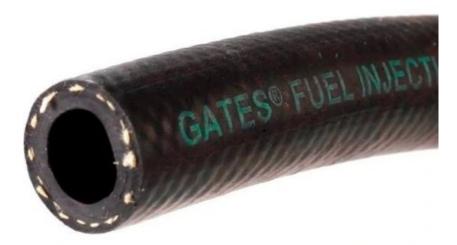
Figure 8\_Manufacturer's mark on the fuel lines

3. Remove the longest section of the fuel line, remove the cover tube and check that the fuel line is marked with the manufacturer's mark.

4. If the fuel lines are made by Gates or cannot be identified, they must be replaced with new ones supplied by Aviation Artur Trendak.

Removed fuel lines are recommended to be replaced with new ones, even if they are not made by Gates.
